Manhole Inspection Summary

Manhole # S43EE_008MH

Insp Date: **6/15/09 2:03 PM**

Location Address: **1717 E. BIDDLE ST [REAR] ALLEY**

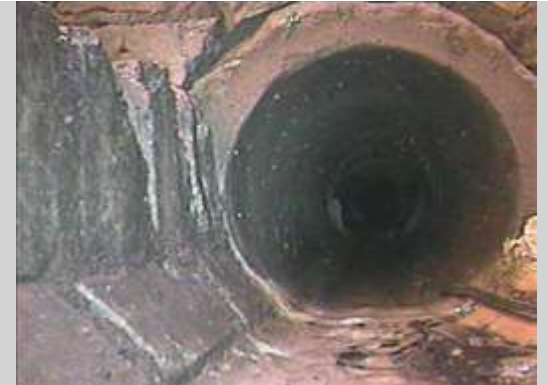
12 O'Clock Outflow

8 in. Circular Gravity Sewer
Pipe Out @ 12 O'Clock

Pipe Height: (in.) Direct
Pipe Material: **Clay** ☐ Pipe Lined
Invert Depth: **8.85** (ft.) Flow Characteristics: **Slow**
Deposits: ☒ None ☐ Mud ☐ Sludge ☐ Debris ☐ Grease
Silt Depth: (in.) Deposits Extent:
Infiltration: **None** Pipe Seal Cond: **Sound**

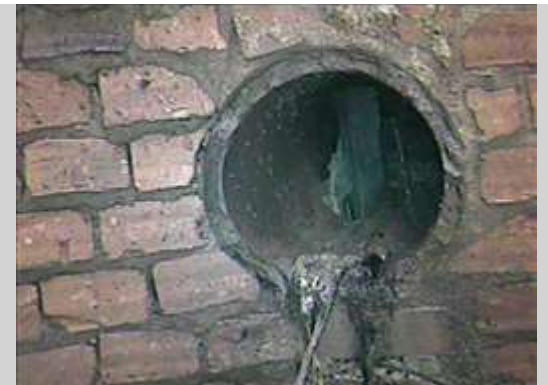
2 O'Clock Inflow

8 in. Circular Gravity Sewer
Pipe In @ 2 O'Clock

Pipe Height: (in.) Direct
Pipe Material: **Clay** ☐ Pipe Lined
Invert Depth: **8.82** (ft.) Flow Characteristics: **Slow**
Deposits: ☒ None ☐ Mud ☐ Sludge ☐ Debris ☐ Grease
Silt Depth: (in.) Deposits Extent:
Infiltration: **None** Pipe Seal Cond: **Sound**

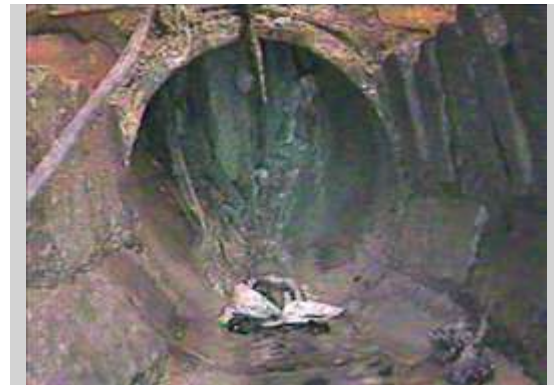
Drop In @ 2 O'Clock

Drop: **Inside** **Direct**
Angled: Reading: (ft.)
Inv Depth: **8.84** (ft.)
Drop Condition: **Open**

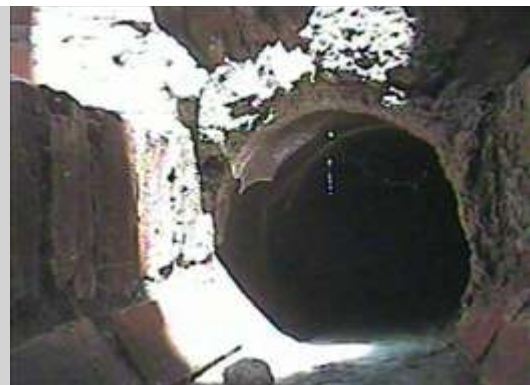
7 O'Clock Inflow

8 in. Circular Gravity Sewer

Pipe In @ 7 O'Clock

Invert Depth: **9.02** (ft.) Flow Characteristics: **None**

Infiltration: **None** Pipe Seal Cond: **Sound**
